Delaware City

Historic Design Standards for the Clinton Street
Historic Commercial District

Prepared for the Town of Delaware City

Center for Historic Architecture & Design
University of Delaware
2003

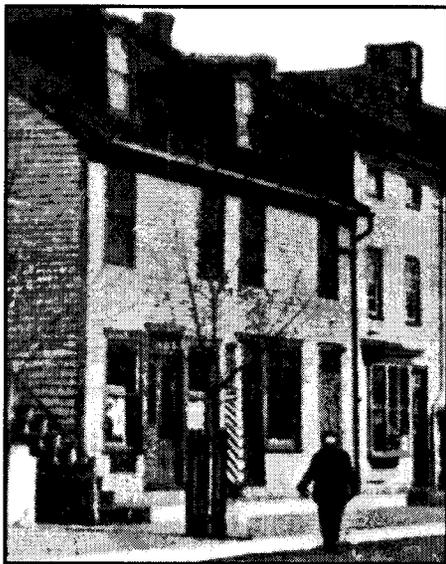
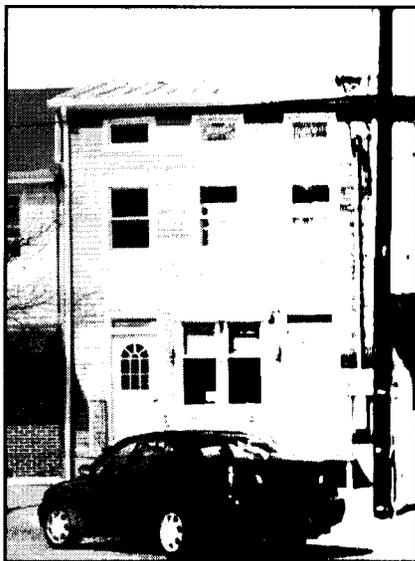
This historic photograph of 62-64 Clinton Street (left) and present-day photograph of 90 Clinton Street (right) illustrate the one-part block configuration. The facades are unified, without any architectural or visual division between the lower and upper floors such as ornamental storefronts, signs, porches, or awnings.

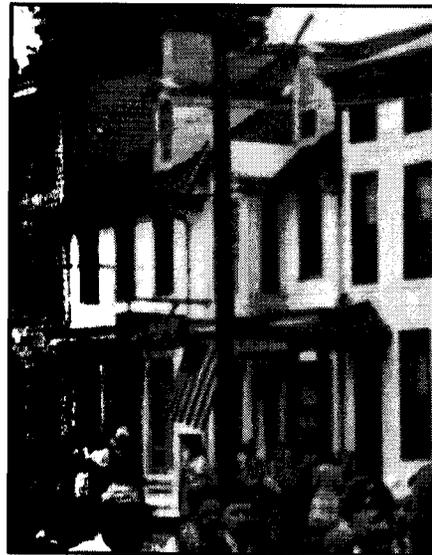
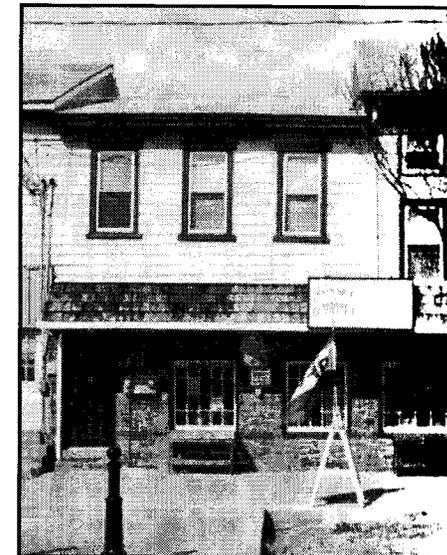
92-94 Clinton, shown here in a historic photograph (left), and a present-day view of 82 Clinton (right), have a two-part block configuration. Both facades are divided between the first and second floors, 92-94 by ornamental storefronts, and 82 by brick veneer and a shingled pent roof

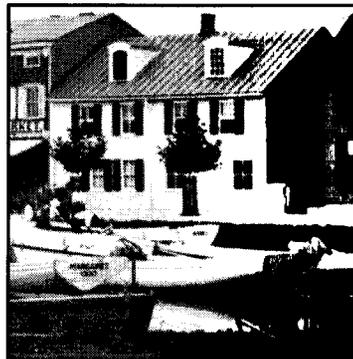
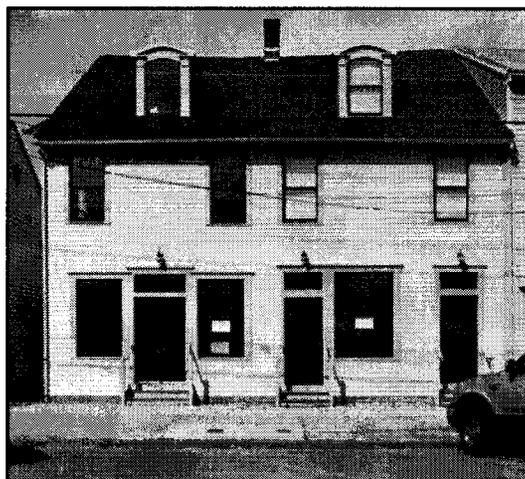
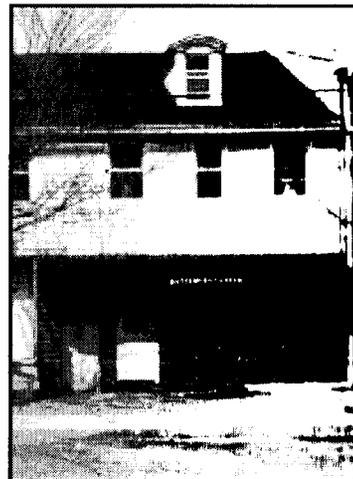
Two sets of Federal style buildings in Delaware City have retained the one-part block configuration, 62-64 (present-day view, bottom left) and 66-68 (historic view, top). With the addition of brick veneer and an awning dividing the upper and lower stories, 92 Clinton Street (present-day view, bottom right), was altered to the two-part block configuration.

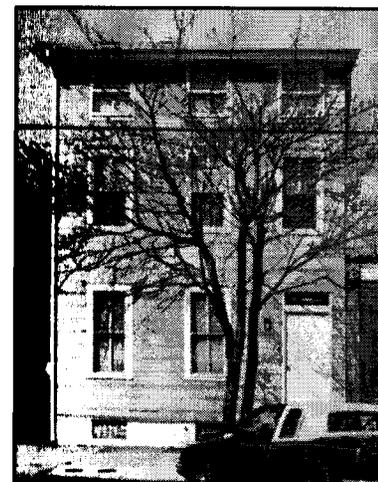
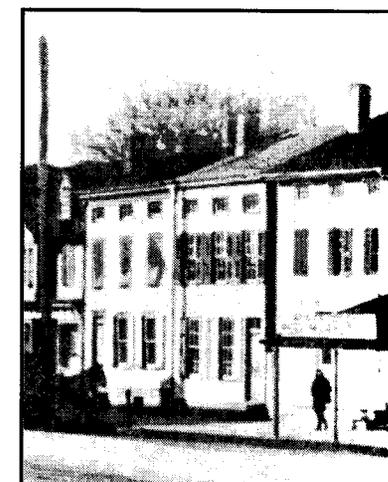
This view of modern-day 44 Clinton Street (left) and historic view of 86-90 Clinton Street (right) are examples of the one-part block Greek Revival style.

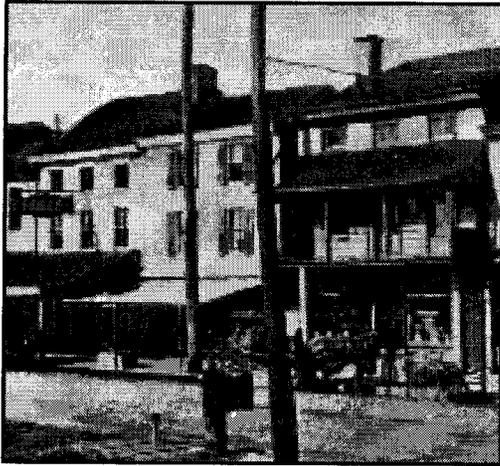
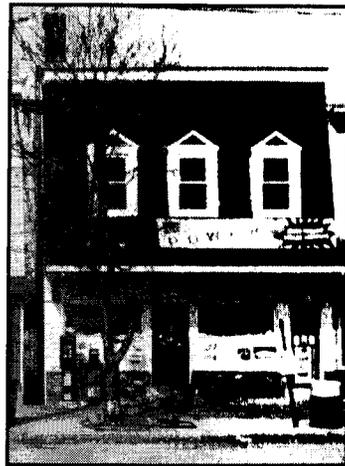
The two-part block Greek Revival style is represented by 76-80 Clinton Street (historic view at left) and 76 Clinton Street (present day view at right).

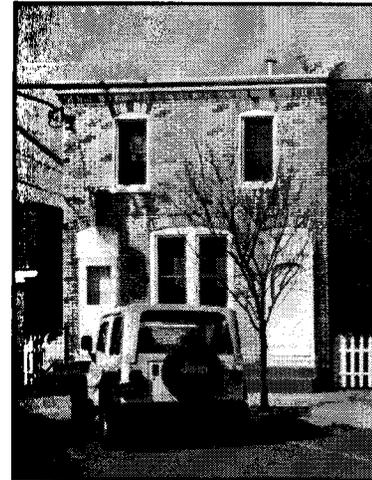
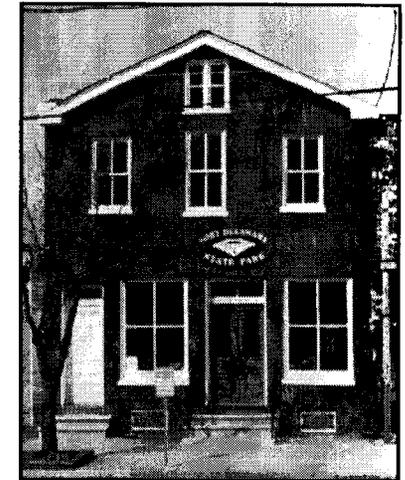
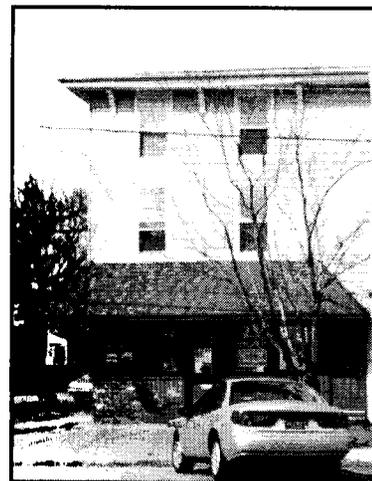
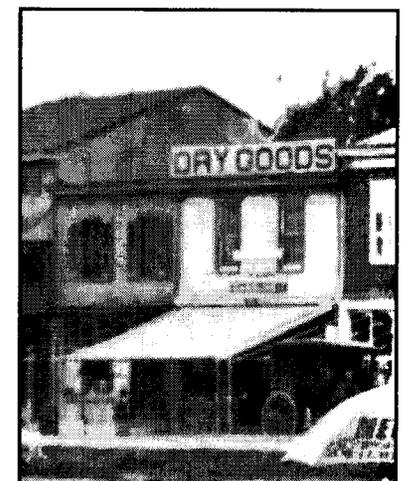
The present-day appearance of 52 Clinton Street (top left) and 38 Clinton Street (top right) is representative of the one-part block Italianate style on Clinton Street, with unified facades and narrow windows.

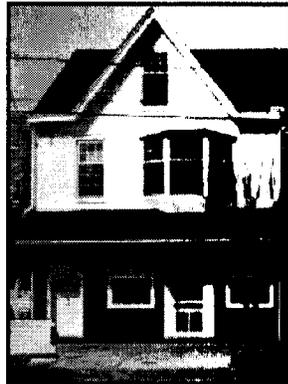
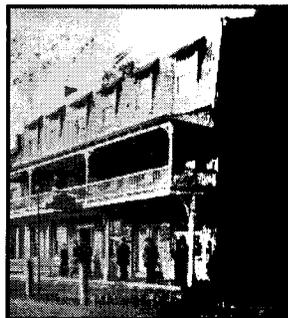
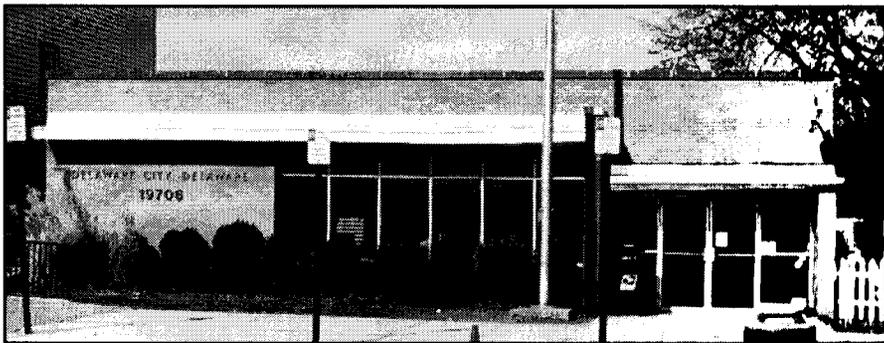
The steeply-pitched front-facing gable of 34 Clinton Street (top) is evocative of the Gothic Revival Style. Renovations made to the third story and roofline of the Old Robinson Hotel (middle) were in the Second Empire style. The Post Office was built on the site of the hotel, and is in a modern commercial style that is incongruent with rest of the block.

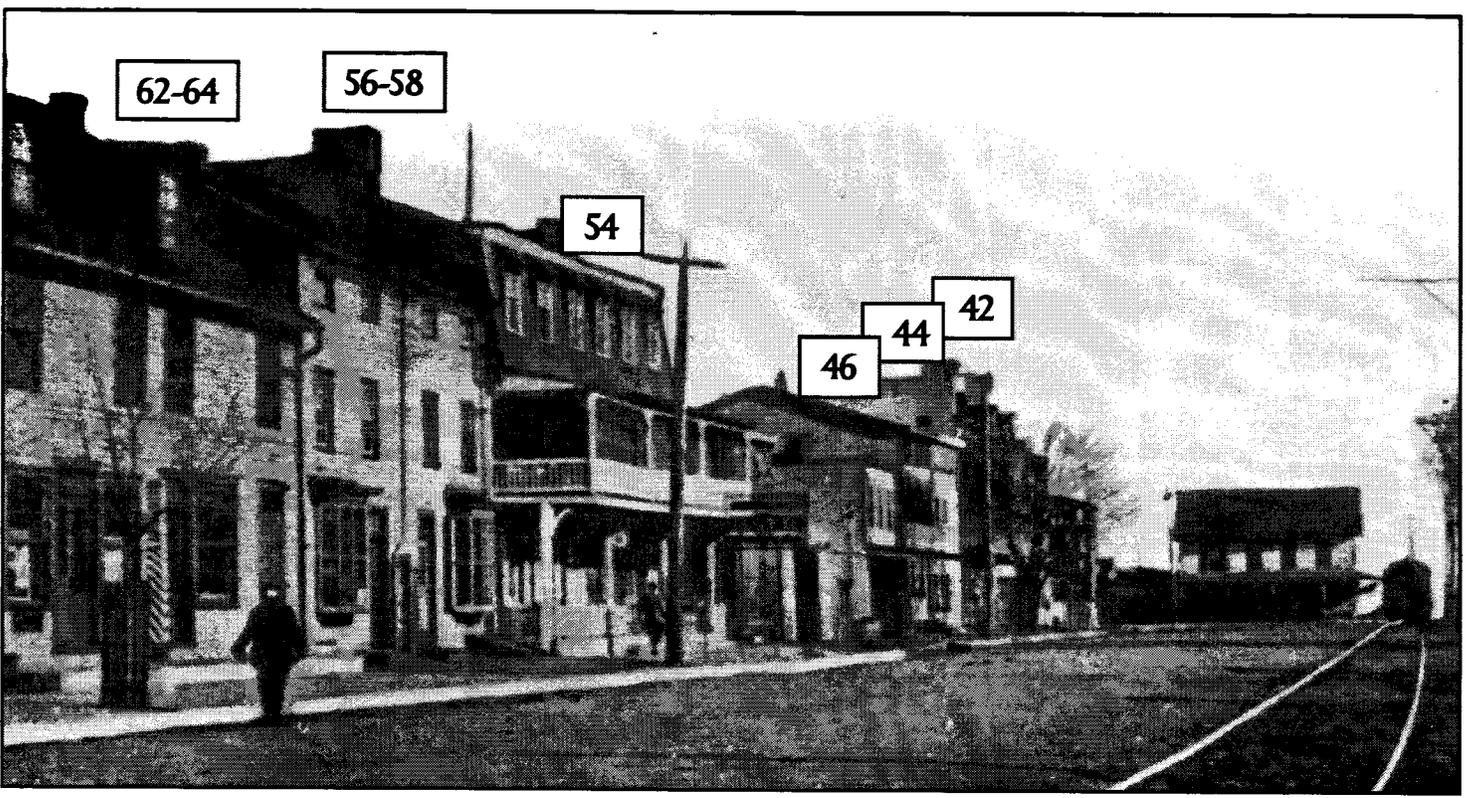
Postcard view of lower Clinton Street in the late nineteenth or early twentieth century looking east. Modern-day street numbers are indicated above each building.

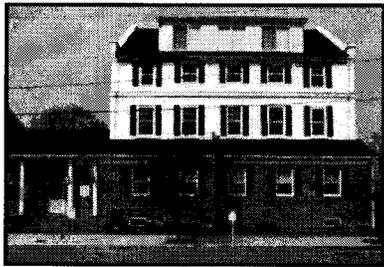
30 Clinton Street

The Olde Canal Inn, also known as the Delaware City Hotel, is one of the earliest surviving buildings in Delaware City, dating to 1829. The one-and-a-half story, side-gabled style building exhibits a symmetrical five-bay arrangement, and the two-part block commercial composition. The third-story frieze band of windows is reminiscent of the Greek Revival style, although the barrel dormers visible in historic photographs are more characteristically

- 1) Remove the enclosed brick front section and entry vestibule.
- 2) Restore the two story front porch with square corner posts and turned spindles.
- 3) Remove the shed roof dormer, and reconstruct three barrel-roofed dormers.
- 4) Replace composite shingle roof with standing seam metal roof.
- 5) Reconstruct the brick gable end walls and chimneys.
- 6) Restore operable canvas awnings to gable end windows to help control sun and heat.

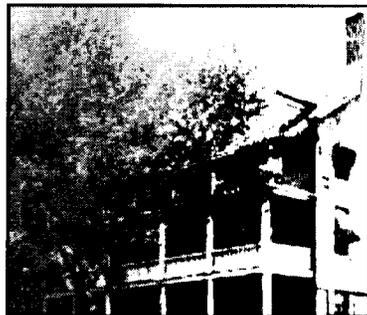
32 Clinton Street

This two-story brick building with frame additions was built circa 1890. The original structure on this property, a frame dwelling listed on the 1868 Beers map as being owned by "T. J. Clark," burned in the fire of 1887. Rebuilt by Alice C. Clark, the property was sold in 1893 to Alexander B. Holliday. It was subsequently used as a lunch shop, tobacco shop and dwelling.

- 1) Restore the canopy clearly delineated on both photographs and Sanborn maps.
- 2) Remove shutters.
- 3) Replace divided light sash windows on first floor with plate glass.
- 4) Replace door with more appropriate glass and panel design.

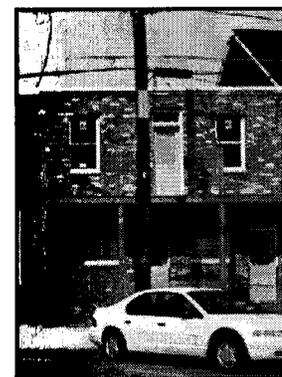
36 Clinton Street

Similar in form to both 32 & 46 Clinton Street, 36 Clinton is a flat-roofed two-story brick building. The façade is asymmetrical, with five bays on the first floor and three on the second. In historic photos, a second-story porch is perched atop a first floor shed roof awning. Today, the second-story door remains over a skeletal porch. Single one-over-one replacement sash windows have been installed on the second floor. The variegated brick face is a modern treatment, and anomalous on the street.

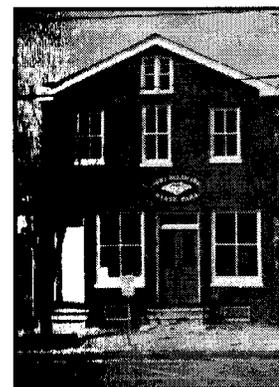
38 Clinton Street

The fire of 1887 destroyed nearly a dozen buildings on Clinton Street, including the original building on this lot. This two-and-one-half story brick building was constructed soon after the fire. An unusual variant of the Italianate style on Clinton Street, this building features a front-facing gable roof. The first floor has a four-bay door-window-door-window configuration, while the second floor has three evenly spaced two-over-two wood single-hung sash windows, altogether forming a one-part block arrangement. A pair of one-over-one sash windows are centered in the gable end at the attic level. A two-story frame porch, once a characteristic of the streetscape, has been removed. The building is listed in the 1904 Sanborn map as "Gents Furr'g" (Gentlemen

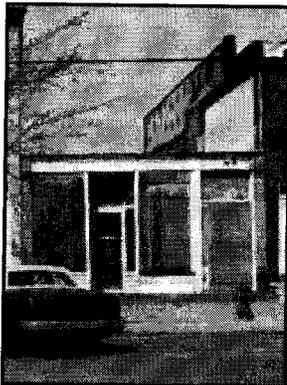
42 Clinton Street

The fire of 1887 destroyed the original building on this lot. This storefront is the surviving section of a circa 1888 building that was constructed after the fire. The three-story frame building was faced with a brick façade. The building matched the height, scale, and window arrangement of its neighbor, 44 Clinton, as illustrated in historic photos. Sanborn maps indicate that the property was used as a barber shop throughout the early twentieth century.

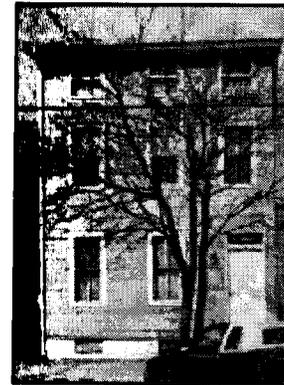
44 Clinton Street

The style of this three-story frame townhouse is characteristic of the slow pace of change in Delaware architecture. Its Greek Revival style, defined by three attic-frieze windows, is reminiscent of the mid-nineteenth century; however, this dwelling was built circa 1888. A fire demolished many buildings on lower Clinton Street in 1887, and this townhouse was built soon after the fire. Historic maps indicate that the building has been used exclusively as a dwelling, not as a commercial property, which accounts for its unchanged one-part block configuration.

The form, mass, and openings on the building have not been changed from their original locations. The low pitch of the gable roof appears flat from the ground. The two-over-two wood sash windows are original to the building.

This building has retained many of its character-defining features, including its two-over-two windows, window surrounds on the first and second floors, window and door openings, roof pitch, and overhanging cornice. However, small losses of historic material have changed the character of this building.

- 1) Restore the molding around the door and attic frieze windows.
- 2) Install a divided-light wood sash transom over the front door.
- 3) Restore attic frieze windows with vertically divided windows (see historic photo of 80 Clinton Street.)
- 4) Remove composite shingle siding and restore clapboard.

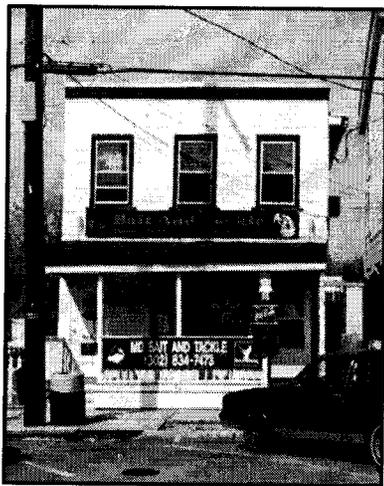
46 Clinton Street

As with other buildings in this section of town, the original mid-nineteenth century building on this site burned in the fire of 1887. Its replacement can be dated by the simple flat-roofed, box-like construction to the turn of the twentieth century, and Sanborn maps indicate a change in building footprint on this lot between 1904 and 1910. Similar in form to both 32 and 36 Clinton Street, the building retains the roofline, mass, and window pattern from the original building. Aluminum siding replaces the original clapboard. The shed porch roof is an important character-defining feature for the building and for the street. However, the raised porch does not appear to be original. Historically, this building was a store dealing in stoves and tinware.

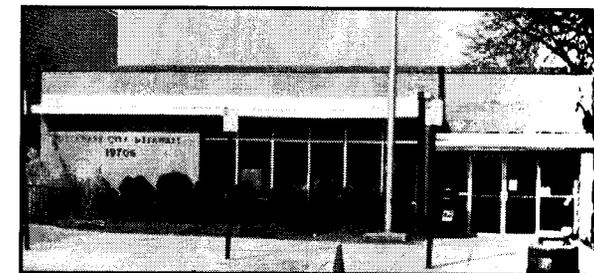
54 Clinton Street

The Delaware City Post Office stands on the site of the old Robinson Hotel.

The hotel was built in two main sections. The first, three-bay section on the west end of the building, was constructed prior to 1868. A second three-bay section was added to the east end of the building prior to 1885, and the whole composition was unified under a mansard roof and two-story porch on the Clinton Street elevation, a two-part block configuration. These buildings served as a drug store and post office before becoming the Robinson Hotel. The current post office, a single-story, one-part block, brick building, was constructed in the mid-twentieth century. The flat roof, light brown brick, and curtain wall of glass windows are characteristic of mid-to-late twentieth century commercial and institutional architecture with a modernist influence.

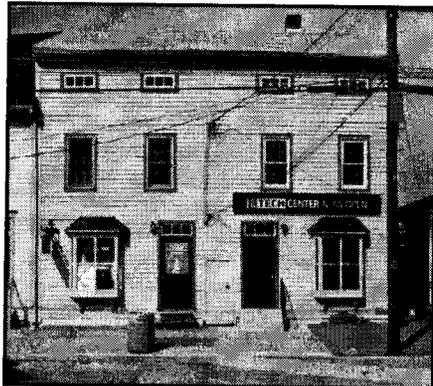
56-58 Clinton Street is a Greek Revival style frame building clad in wood clapboard on the front elevation, and vinyl siding on the side and back elevations. Constructed as a mirror-image pair of buildings under one roof, each of the two and-one-half-story buildings are two bays wide, with a door and window in each bay, in a one-part block configuration. The outside bay on the first floor of each building is comprised of a bay oriel window supported by brackets and covered with a standing seam metal roof. The second floor of each unit contains alu-

It is important to note that the outline of the original bay windows on the first floor have been changed. The windows originally had low-pitched roofs, as seen in the historic photo. The new windows have steeply angled metal roofs, likely styled to prevent water accumulation.

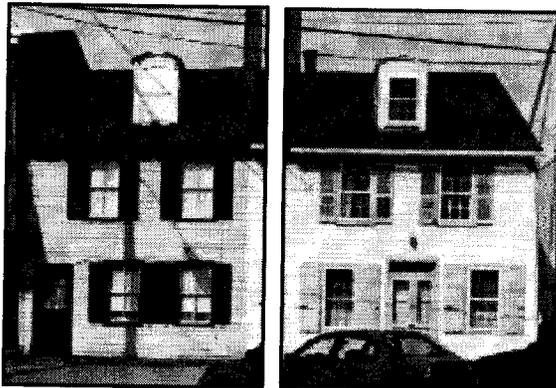
66-68 Clinton Street

The buildings at 66 and 68 Clinton were constructed as a pair of dwellings. Manuel Eyre purchased the lots for 66 and 68 Clinton Street in 1828 from Michael Newbold, one of Delaware City's founders. Eyre probably constructed the adjoining buildings during the 1830s. 68 Clinton was used as a bakery from 1885 through 1891, and was converted back into a dwelling by 1904.

Photographs from the late nineteenth century show two-over-two light window glazing and a bay window at the first floor. 66 Clinton was used as a grocery from 1885 into the early part of the twentieth century and several historic photographs from the 1910s show a deep canopy over the sidewalk at this building.

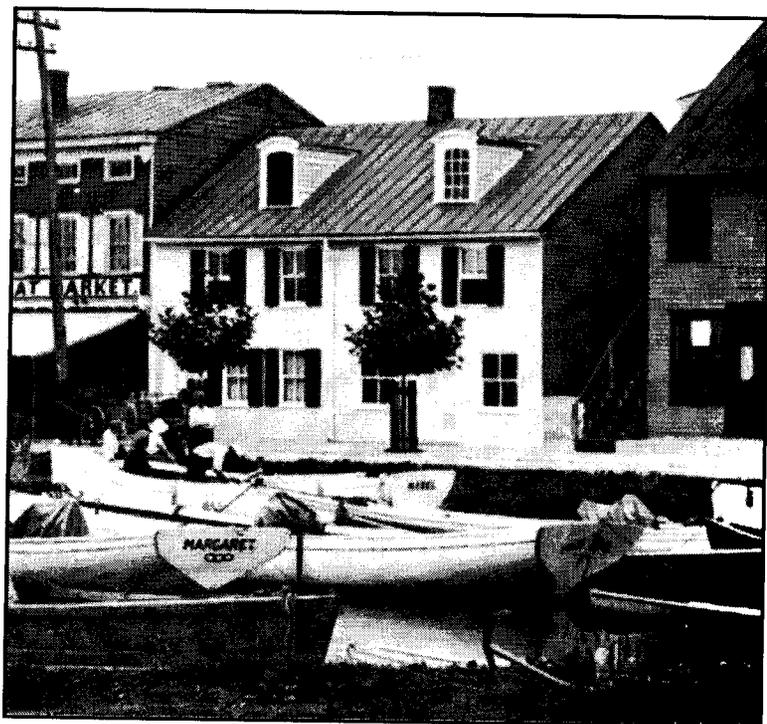
Simple in detail, these two-and-a-half story Federal townhouses are of frame construction with three first-floor bays, two second-floor windows, and a third-floor barrel-top dormer centered over each façade. The gable roofs were originally clad in metal. The building at 68 Clinton has a side entrance, windows with two-over-two divided lights, and shutters. The 66 Clinton dwelling has a center entrance with a window opening to each side. Both units feature the one-part block configuration, with no physical or ornamental division between lower and upper floors.

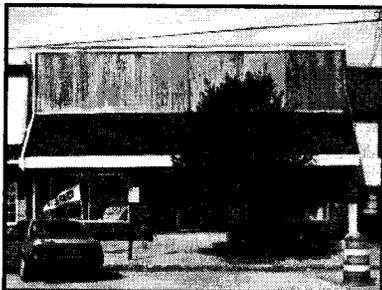
70 Clinton Street (formerly 70 & 72)

Originally composed of two buildings located at 70 & 72 Clinton Street, 70 Clinton Street was combined into a single store in the twentieth century.

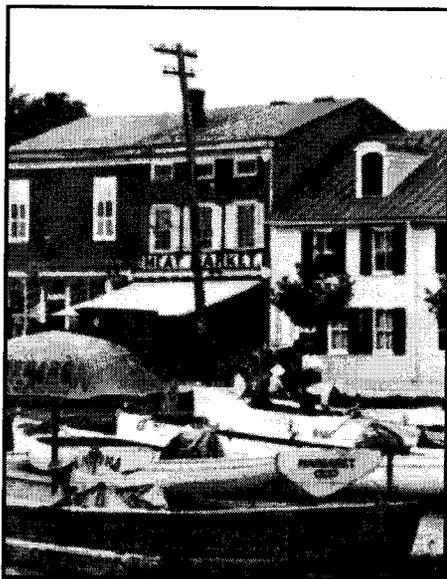
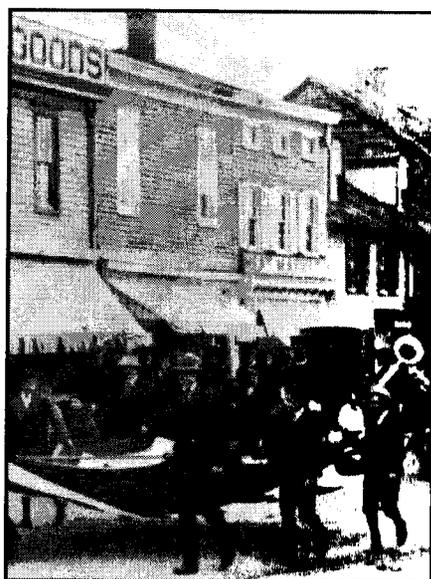
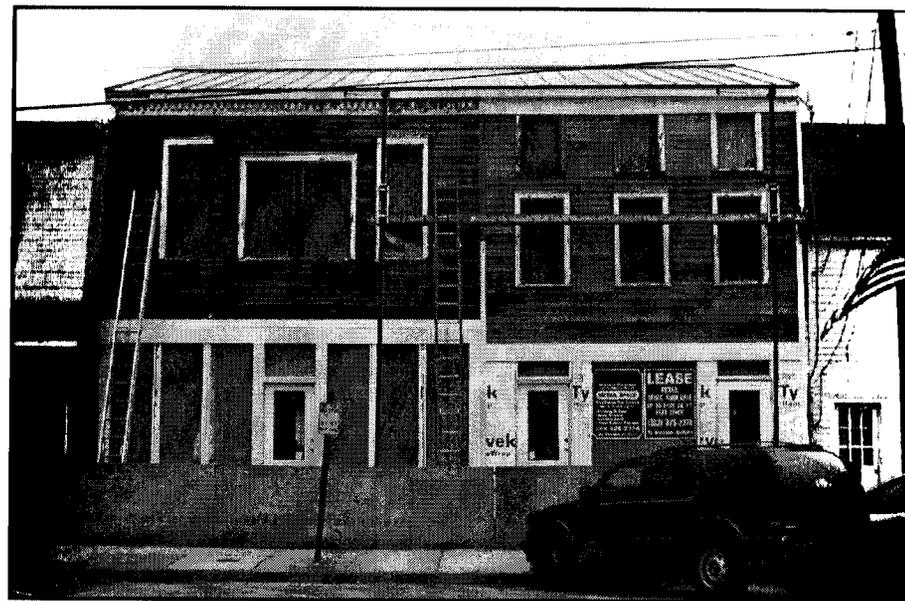
renovations altered the façade into a two-bay, two-story frame building with a recessed side entrance and large glass storefront. Both buildings supported deep awnings spanning the full width of the facades, which was typical for Clinton Street in the late nineteenth century. Historic maps show a building on the lot at 70 Clinton Street in 1868 with a vacant lot next to it at 72 Clinton, which was probably constructed in the last quarter of the nineteenth century.

The current building is now a three-bay, two-story wood frame structure. The first floor has a center entrance with large plate glass windows on either side. The front wall features two large plate glass display windows above a brick veneer. The upper floor is been covered with a painted plywood mansard-style roof. None of the existing windows openings on the upper floor are visible from the exterior. A pent roof has been added above the storefront windows and is covered by composite-type shingles. The building has a side gable, low pitch tin roof that is consistent with the historic photographs. An original brick chimney on the gable end of 70 Clinton was removed with the twentieth century modifications.

When 70 and 72 Clinton were combined under a single facade, the building lost its architectural integrity. The storefront level was completely modified to accommodate a single center entrance where originally there were two. At the first floor, the brick veneer, storefront windows, and plywood roof hid whatever remained of the window openings at the upper level. However, recent renovations to the building (pictured above) have uncovered much of the original facade. The building is well on its way to recovering its historic appearance.

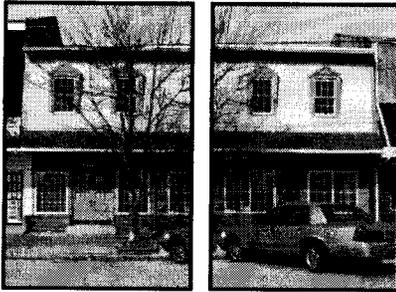
Originally two Italianate buildings, 72-74 Clinton Street have dramatically changed from their appearance at the turn of the century. Historical photographs circa 1900 show two frame row houses of similar proportion, with side gabled roofs and clapboard siding. Both buildings had the distinct two-part box division, with commercial uses on the first floor, and residential uses on the upper stories. On the first floor, 74 Clinton had a side entrance and a plate glass storefront win-

- 1) Remove the modern mansard cladding on the second floor façade and the gable dormers over the windows.
- 2) Recreate the original window openings. 72 Clinton had six-over-six sashes, while 74 Clinton had two-over-two sashes with louvered shutters.
- 3) Redesign the storefront on the first level to appear as two distinct buildings, or at least be sympathetic to other historic storefronts on Clinton Street

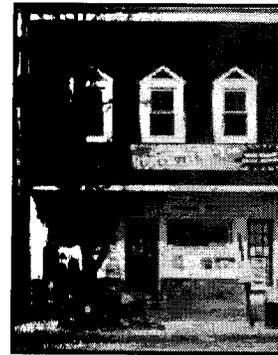
76 Clinton Street (formerly 78 Clinton)

The street façade of 76 Clinton Street has radically changed since the building was constructed in the mid nineteenth century. While it currently retains the historic two-part block commercial division with a liquor store on the first floor and residential living space in the upper floors, all of the original finishes on the façade have been removed or covered. The building was constructed in the mid nineteenth century, and appears on the 1868 Beers map belonging to W. J. Robinson. According to Sanborn maps, it was used as a drug store throughout the late-nineteenth and early-twentieth centuries.

Constructed in the Greek Revival style, the four bay, two and a half story frame building was originally clad in clapboard and had a standing seam metal roof. The first floor featured a central door recessed between plate glass display windows. A second door, offset on the northeast end of the building, provided access to the upper floors. The second and attic stories are three bays wide. A door in the central bay of the second floor opened onto a two story porch with a distinctive curved porch roof. A band of two-light attic-story windows ran under the cornice of the side-gable roof.

3) Replace synthetic shutters with authentic wood shutters.

4) Remove vinyl siding and restore original clapboard siding or replace with new wood clapboard siding, keeping the proportions of the original clapboard reveal.

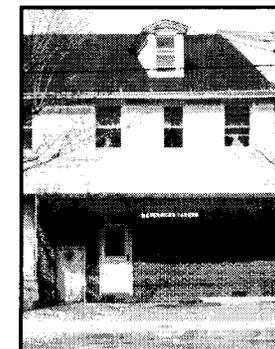
92-94 Clinton Street

One of several pairs of duplexes in the business district, 92 and 94 Clinton Street exhibit an amalgam of architectural elements. Both are three-bay, two-and-one-half story frame structures with side-gable roofs and two-part box configurations. The barrel-roofed dormers of both buildings are characteristic of the earliest Federal style buildings in Delaware City,
